H-60 WIRING SYSTEM AWARENESS

PREVENTING WIRING SYSTEM FAILURE

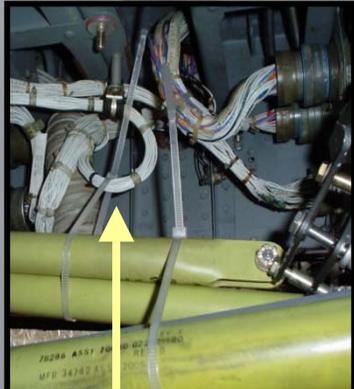
Flight control tubes tied to wiring inducing stress.

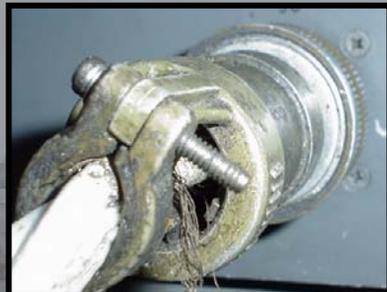
Shielding deteriorated, no longer provides EMI protection to system.

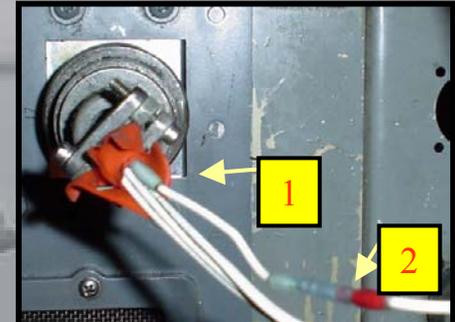
Worn tape at strain relief. Wire has two splices within inches of each other (should only have one splice).
