# How I Got a Red Face

*By AE2(AW) Edward Burden*

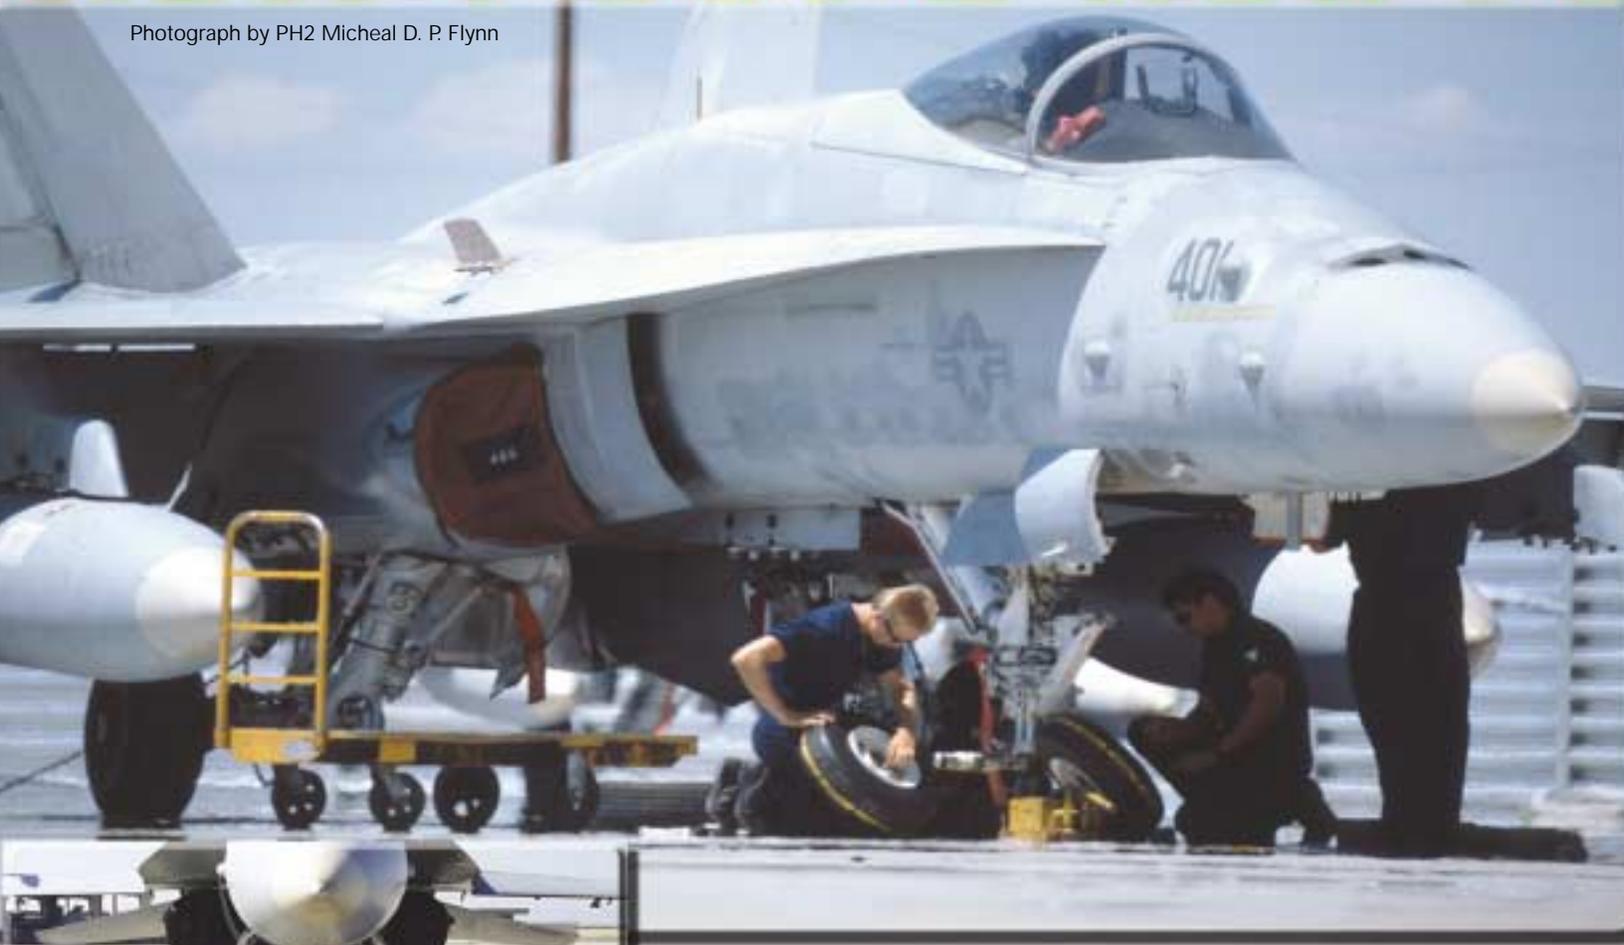
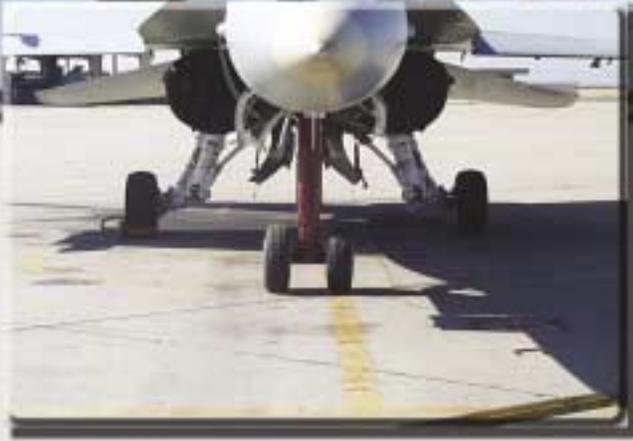
A "red leg" takes the place of a strut that isn't available.

That jet now sits like a permanent fixture. It has a dummy strut (called a "red leg)," and I live with the knowledge that my mistakes put it there.
