Twisted Metal

By AM2 Jonathan Parker

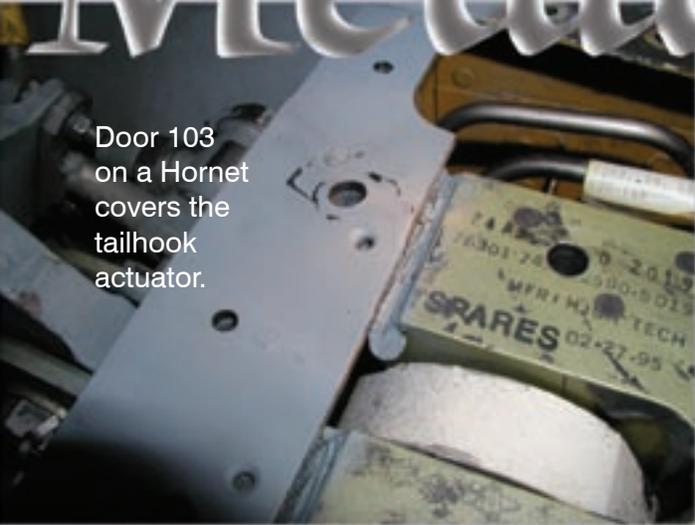
Door 103 on a Hornet covers the tailhook actuator.

Having done this job countless times, I felt I knew how to install a tailhook actuator. One well-known step in our shop is to make sure door 103 is installed before operating the tailhook or moving the speedbrake, which is located directly above door 103 and the tailhook. The book repeats this caution several times and explains how to remove and replace this actuator. It states, "Structural damage may occur if door 103 is not completely installed and either the tailhook or speedbrake is operated." During the job, this caution was noted, and the steps for installing the tailhook

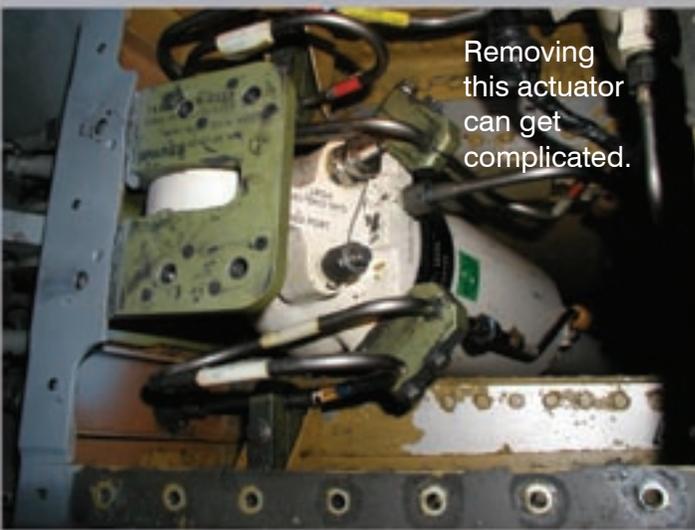
Removing this actuator can get complicated.

As the day progressed, we removed several parts, ordered new ones, and installed them. The work was going well: The switching valve was in, the lines were tight, and the system was ready for an operational check. Replacing the tailhook actuator was complicated and was taking longer to complete. I took a break after my task was done and then relieved the CDI on the tailhook job, so he could eat lunch. This step meant we wouldn't lose any time installing a new tailhook. He showed me his work and then left for chow.

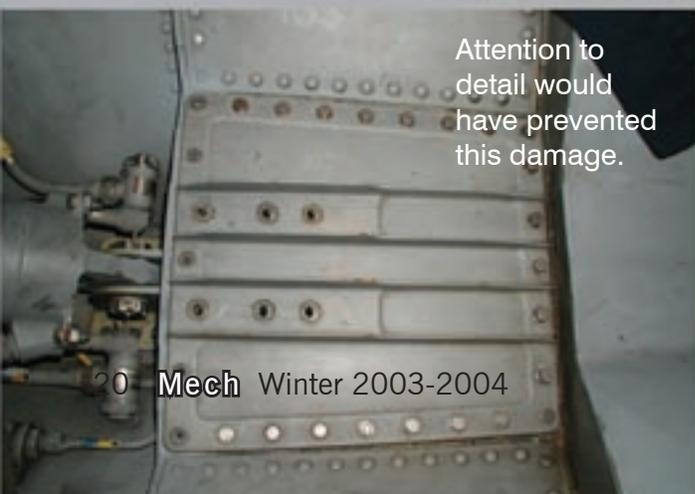
Attention to detail would have prevented this damage.
