LEARNING A FLIGHT-DECK LESSON

By JO3 Megan Moline

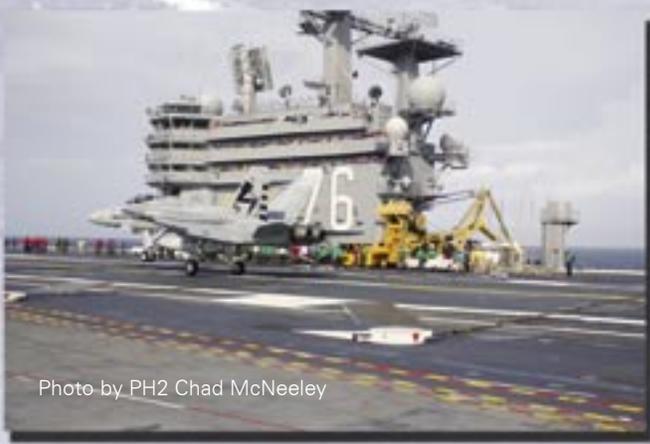
It took only a glance for ABEAN Jorge Linarez to see something was wrong. This at-sea period was the first time USS *Ronald Reagan* (CVN-76) was landing and launching aircraft. While on watch and working on the port side of the ship, one deck below the flight deck, the airman did routine inspections. Moments later, smoke and metal shavings appeared from the fairlead sheave—an area that houses the wires used for landing aircraft. He alerted his supervisor, and all landings were stopped. Linarez's actions made sure that the malfunctioning gear injured no one.

Ltjg. Kyle Caldwell, *Reagan's* air boatswain, explained the sheave wasn't working right. "When an aircraft lands on the flight deck, the cable feeds out from the sheave. What happened here was the sheave wasn't turning," Caldwell said. "That made the cable saw into the hub. If it hadn't been noticed as soon as it was, the cable might have cut right through the hub and could have been severed. If a cable breaks on the flight deck, it's like a rubber band snapping, and the force can cut through almost anything."

While recovering aircraft during one of the underway periods, two sheaves seized due to corrosion build-up from the rain while sitting pierside, according to Caldwell.

"During our first incident, the grease seal didn't allow the lubricant to escape while doing preventive maintenance (PMS), causing the sheave to seize," said Caldwell. "The corrosion attacked the sheaves because the grease seal had been removed. We took it off to correct one problem, not knowing it would cause another type of problem."

The ship returned home to adjust the arresting-gear system, requiring all 58 sheaves to be removed. We removed, lubricated and then reassembled their seals—a job that takes about four hours per sheave, according to Caldwell. The ship was back at sea less than two days later to continue the certification process.
