Wing-Tip Crunch Teaches Communication Lesson

By AD1 Zamir Alvarez and AM1 Philip Carter

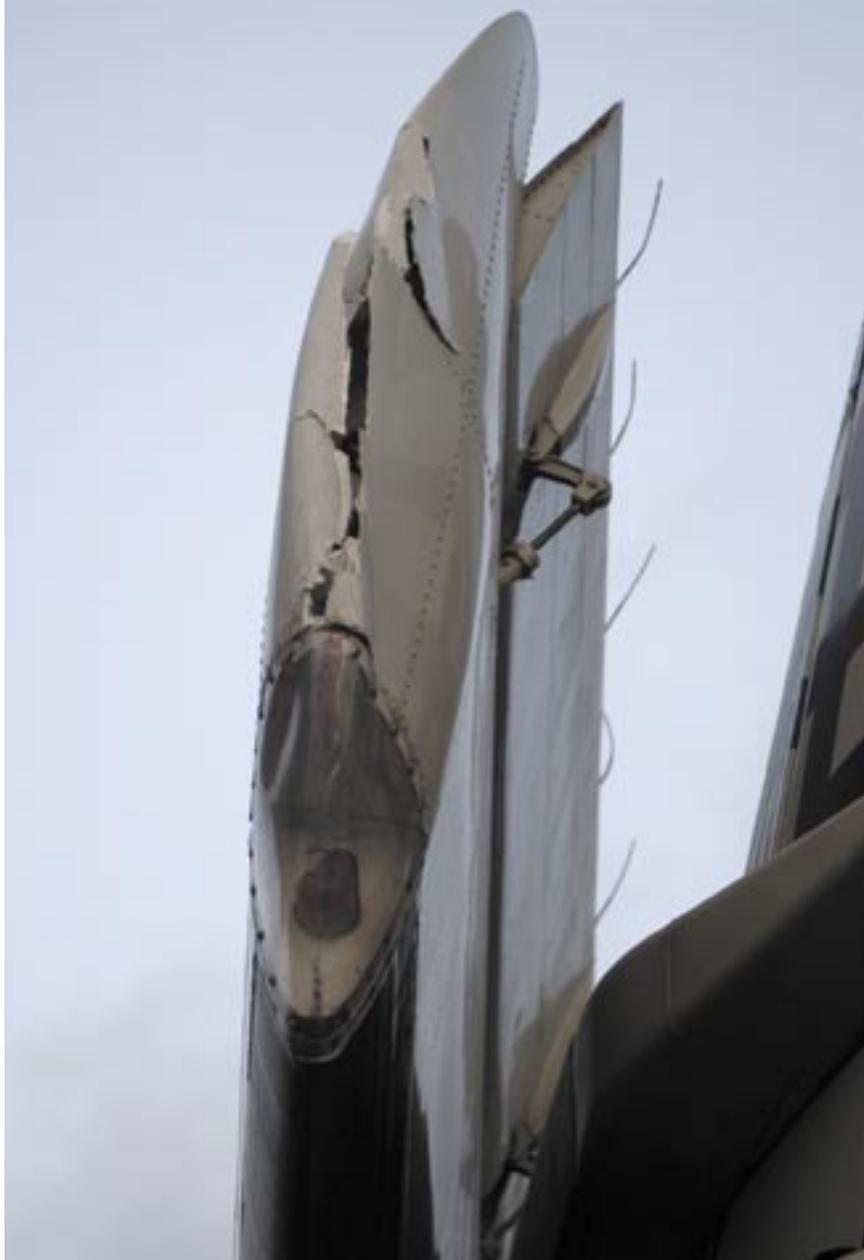
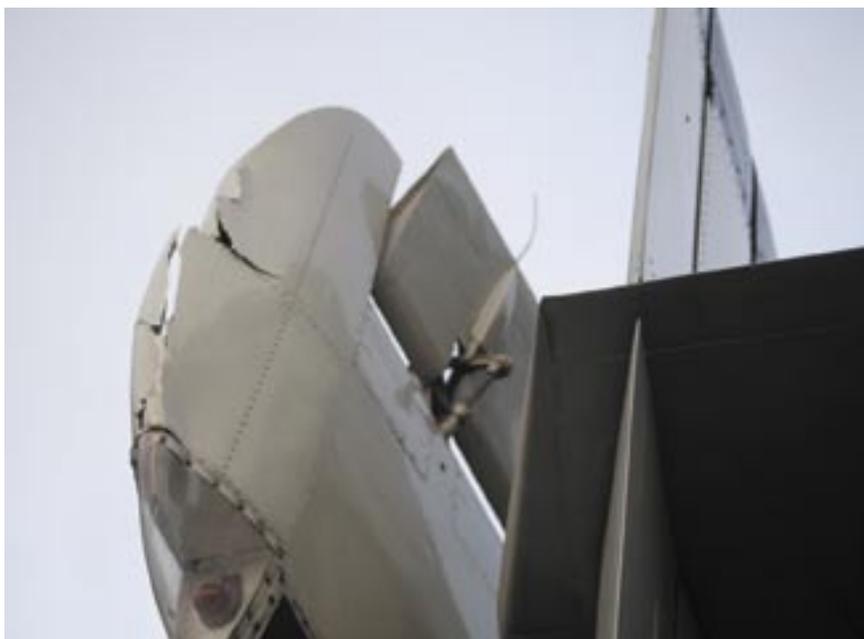
This is where our communication failed. After seeing my signal, the yellowshirt relayed the same signal to the pilots in 601. The pilots saw that signal and, unaware that there was a dangerous situation developing near their left wing, they thought the signal was intended to stop the aircraft, instead of the wing-spread. The pilots continued to hold the brakes, but they did not reverse the wings.

Unbeknownst to the pilots, the port wing clipped the P-25 and lifted the fire truck off the deck a few inches, destroying the outer wingtip. Needless to say, this problem downed the aircraft resulting in a failed launch.

Complacency, error in executing proper flight-deck procedures, and a break down in communication resulted in the damage of an aircraft. Fortunately no one was hurt, but simple communication between airwing personnel and carrier flight-deck personnel could have prevented this crunch from ever happening. 🌸
