By Cdr. Dave Bean

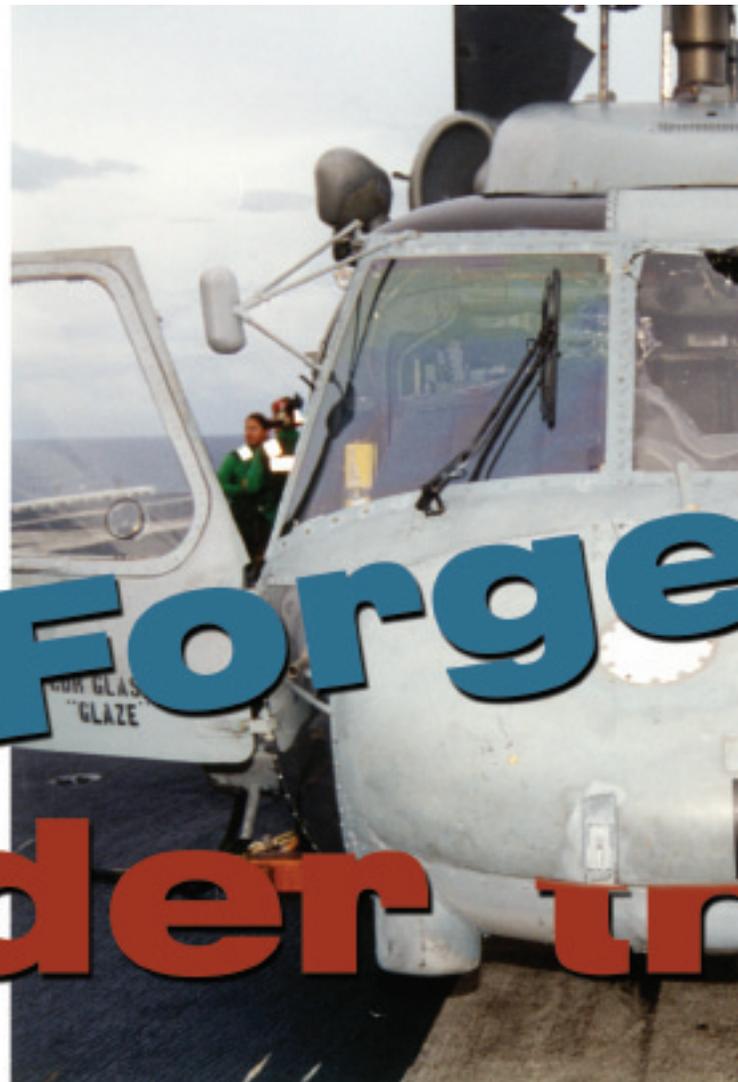
A short time later the crew was airborne and started another maintenance auto. Following their entry into the maneuver, the electronics-compartment door rotated violently up and aft, crashing into the windshield wipers and the OAT gauge located in the center windscreen. Although the two glass screens in front of each pilot were cracked badly, they remained intact. The plexiglass in the center screen, however, broke into pieces, which then became missiles with sharp edges, hurtling aft through the cabin.

Because the door remained fixed against the windscreen, the crew effectively was operating IMC. The crewman in back was able to give verbal directions to the pilots by leaning out the cabin door on the starboard side of the aircraft. The crew still had difficulty finding the ship as they navigated around the isolated showers. As fortune would have it, the ship had established EMCON, and it took some strong words of encouragement for them to answer on the approach frequency. Before receiving radar vectors to the ship, the effects of the rain soon hit the AFCS computer, which failed en route because it had gotten wet. Even though the crew had no flight-control stabilization and no forward visibility, they brought this tale to a happy end by recovering aboard the carrier just a few minutes later.

What's worth learning from this misadventure? Spend time checking the security of your

aircraft, especially following maintenance. Did the AEAN leave the door open? This crew focused only on the area where the power-plants troubleshooters had been working. There wasn't a standard requirement to touch the door latches to ensure security. A visual check of the aircraft was all that was done. Given the position of the latches, they might have appeared to be closed.

The value of wearing helmet visors down was reaffirmed. The plastic shrapnel went whistling through the aircraft cabin and grazed the cheekbone of a crewman working the VATS gear in the after station. He escaped with only a superficial laceration. The plastic just as easily could have hit a less forgiving target only a few centimeters away had the petty officer not been wearing his PPE. The two pilots—neither of who had his visor down—suffered from corneal windburn during their return flight to the CVN. 🦅
