Tankers, Ski

By Capt. Jason Arthaud

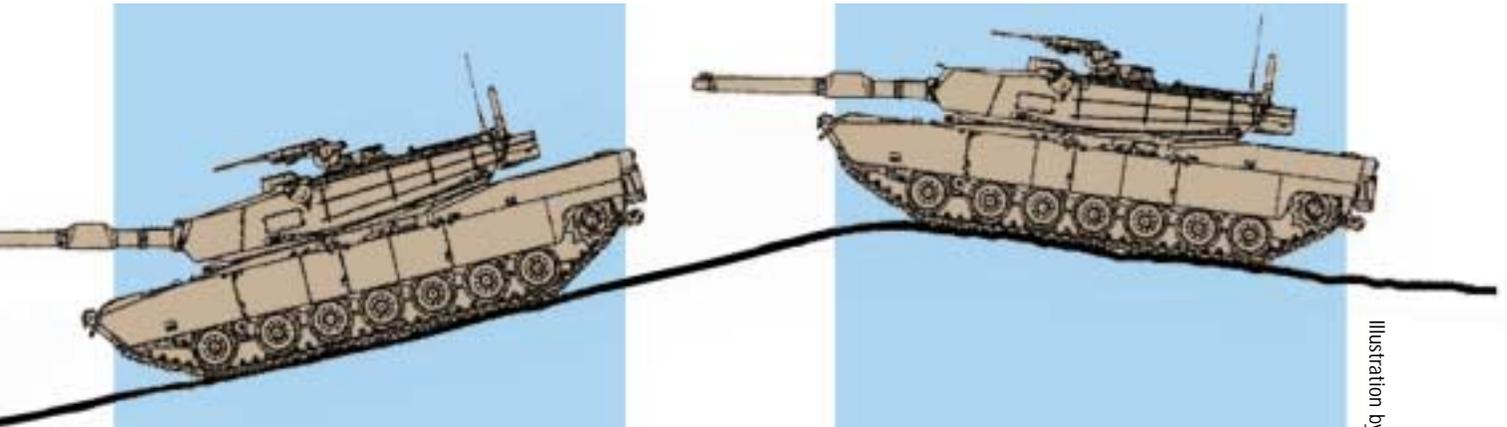
1. When the tank took off in reverse, the loader lost control of the round and it struck his chest and knocked him toward the breech.

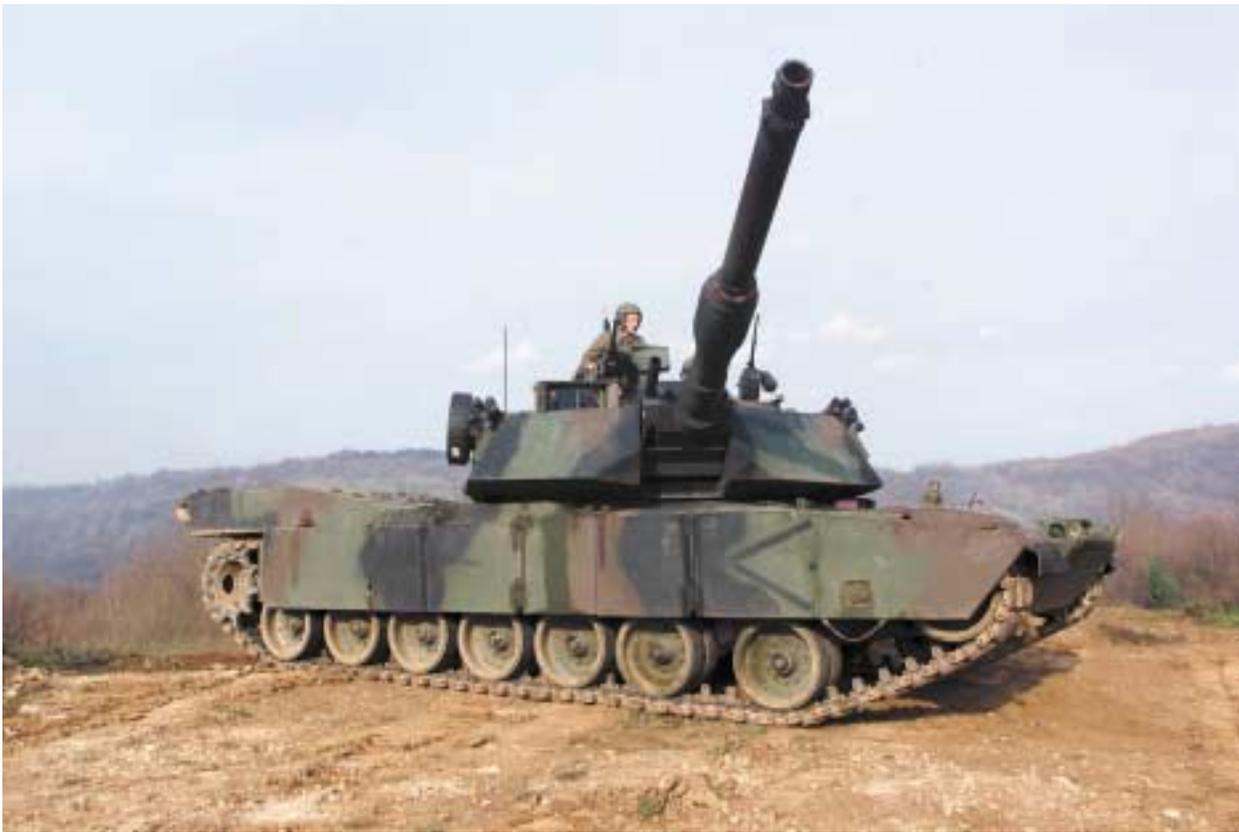
3. While over the breach, the tank crested a slight rise. The stabilized gun swung down to stay on target, and the breech-block swung up and crushed the loader's head.

By not switching the GTD to the elevation-uncoupled position, the gun was still under the commander and gunner's control, a dangerous condition for loading while moving. When the tank backed over the rise in the rough terrain, the gunner was tracking a target. Since the main gun was stabilized, "slaved to the sight," it moved up and down as necessary to stay on target. The loader's head was over the breech when the tank crawled over the slight rise in the ground. When the tank crested the rise, the muzzle end of the gun depressed to stay on target, and the breech end swung up and crushed the loader's head.

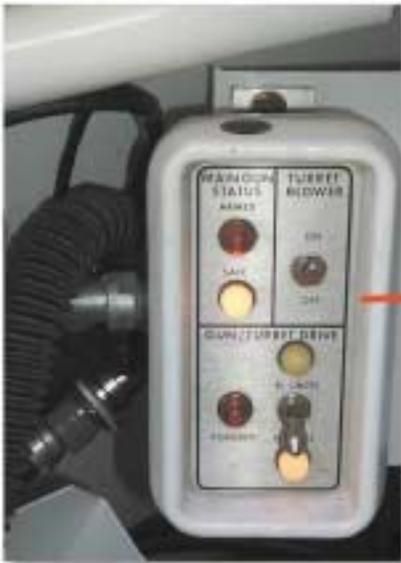
GTD panel

Examination of the tank found that the gun-turret drive (GTD) switch was in the wrong position when the lance corporal tried to re-load. The GTD switch, operated solely by the loader, should have been set to EL UNCPL. This setting locks the gun and keeps the commander and gunner from moving it up or down. If the main-gun is locked at zero degree elevation, a loader can safely load and move about his station. Investigators found the loader skipped this step.

The GUN/TURRET DRIVE panel switch has three settings; EL UNCPL, POWERED and MANUAL. Once set to EL UNCPL, the gun automatically returns to POWERED and back to EL UNCPL as the arming lever is raised to the ARM position or lowered to SAFE.

Is it really necessary to have the main gun in EL UNCPL all the time? According to the TM, and now the FM, yes, at least when moving. Many tankers consider the feature a convenience for use only if and when the gun is depressed or elevated at extreme angles. Using EL UNCPL in a stationary tank may seem unnecessary. However, when the gun is powered, and the tank is moving over rough terrain, you risk repeating this mishap.
