Our Massive Prop- Overspeed Flight

by Lt. Brendan Berry

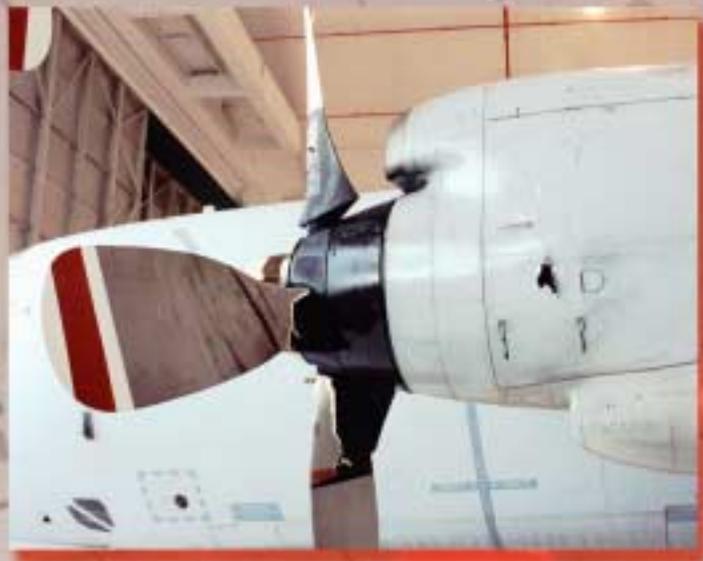
Postflight revealed the prop had oversped to 165 percent, although the gearbox is only guaranteed to 115 percent by the manufacturer. The spinner and much of the deicing cuffs and islands had separated and struck the fuselage at several points, causing dents and the popping noises we heard. The No. 2 EDC had had an uncontained failure, sending shrapnel throughout the inside of the No. 2 nacelle, puncturing the nacelle in several places, and also sending a large piece through the top of

the No. 1 nacelle, bouncing off the oil tank mounted on top of the engine.
