Basket Case

By AD1(AW) Glenn Kildare

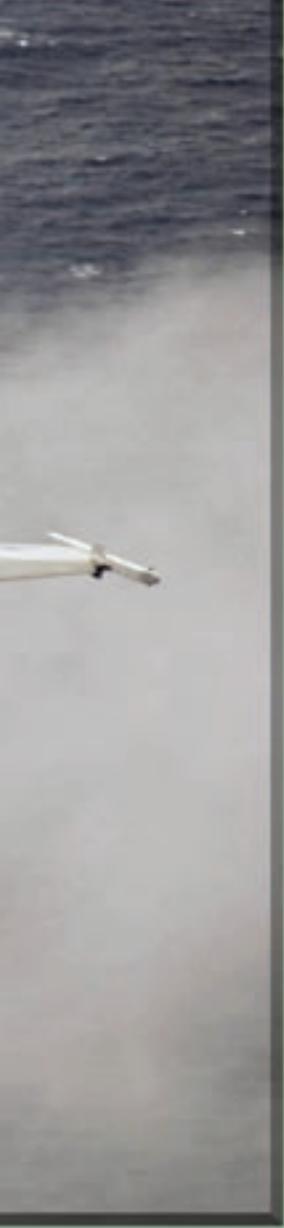
Once 106 was on deck, we downloaded the ARS pod and began our investigation. After removing the pod's tail section, we noticed 8 feet of the hose was jammed and tangled around the drum, preventing the hose from streaming or retracting completely. We checked for correct synchronization of the drum-and-reel guide and found it was aligned correctly. We then found the hose guide would not move through its full path of travel. Upon closer inspection, we noticed a bolt and nut were installed incorrectly in the hose-guide track. The locknut was protruding along the track and prevented the full travel of the hose guide, causing the hose guide to shear and to jam the hose.

A flathead, counter-sunk screw with a locking nut should have been installed in the track with the head flush to the surface of the guide. In its place, however, was a three-eighths-inch, hex-head bolt and castellated nut. When maintenance had been done two days earlier, the CVW-11

ARS team had replaced the W-300 wire harness. This action required removing and replacing the entire hose-guide assembly and track. An ADAN did that job, but he did not have or use the required publication (strike one). A CDI was not present (strike two).

The publication clearly showed the correct type and position of the screw and locknut. Deciding it was not major maintenance, the ARS team incorrectly did a daily inspection, instead of the required full operational test on the pod (strike three). The daily deck required the hose to be extended only 6 feet and then retracted into the pod. After the rest of the checks were completed, the team concluded the pod was good to go and signed off the discrepancy.

The ARS team should have extended and retracted the hose assembly completely, which would have highlighted the bad maintenance. When the aircrew extended the hose on the first flight, the hose guide traveled along the guide until it hit the protruding nut and sheared the connection between the drum and guide—this function worked as designed. The hose eventually wrapped over itself and fouled the pod, causing the crew to jettison it.

Maintainers need to use the book and do a thorough CDI inspection. It is the only sure way to get the job done right the first time, and those steps will help make the 50-percent reduction goal a reality.
