The Simple Things . . .Part II

What Was Routine Became a Disaster

By Steven R. Southard,
Naval Sea Systems Command Deep
Submergence Branch

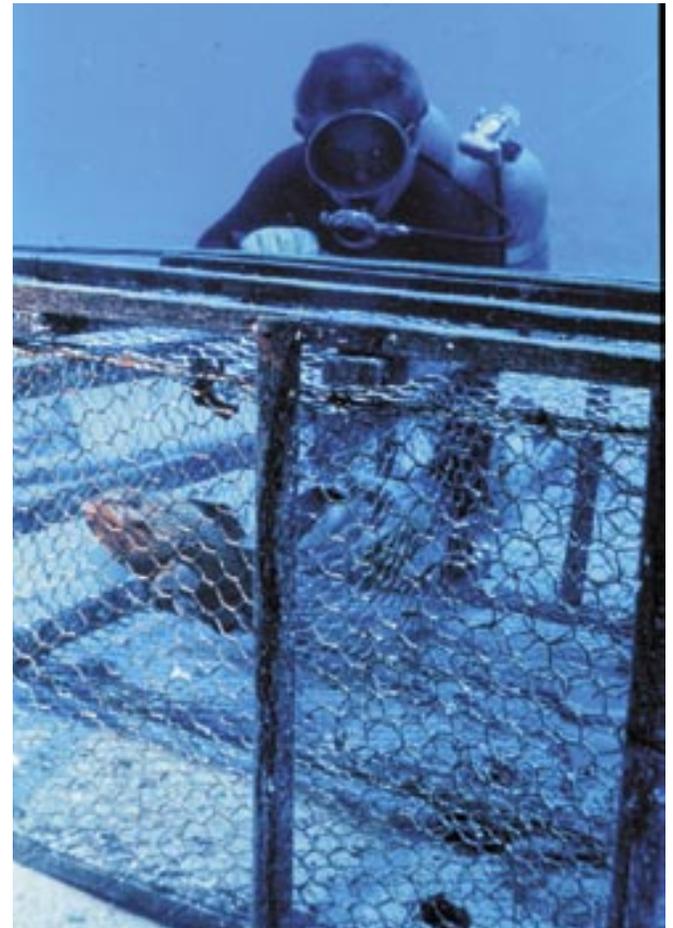
The *Johnson Sea Link* was to collect a fish trap like this one and placed on a Navy destroyer to determine the hulk's effectiveness as an artificial reef.
