The Simple Things (Part 3):

When Small Errors

By Steve Southard,
Staff, ComNavSeaSysCom

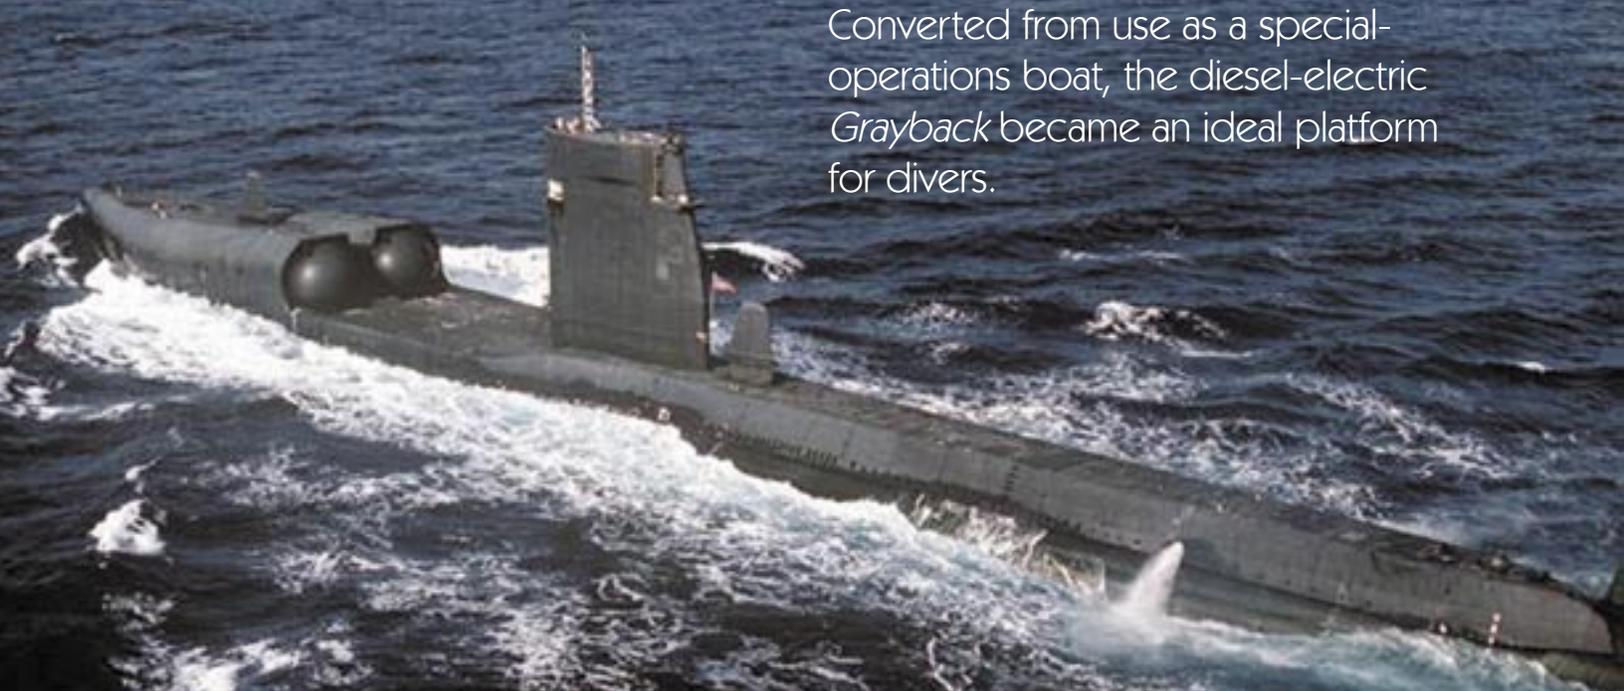
Converted from use as a special-operations boat, the diesel-electric *Grayback* became an ideal platform for divers.
