# How Low

By LCdr. Larry Young, HSL-51

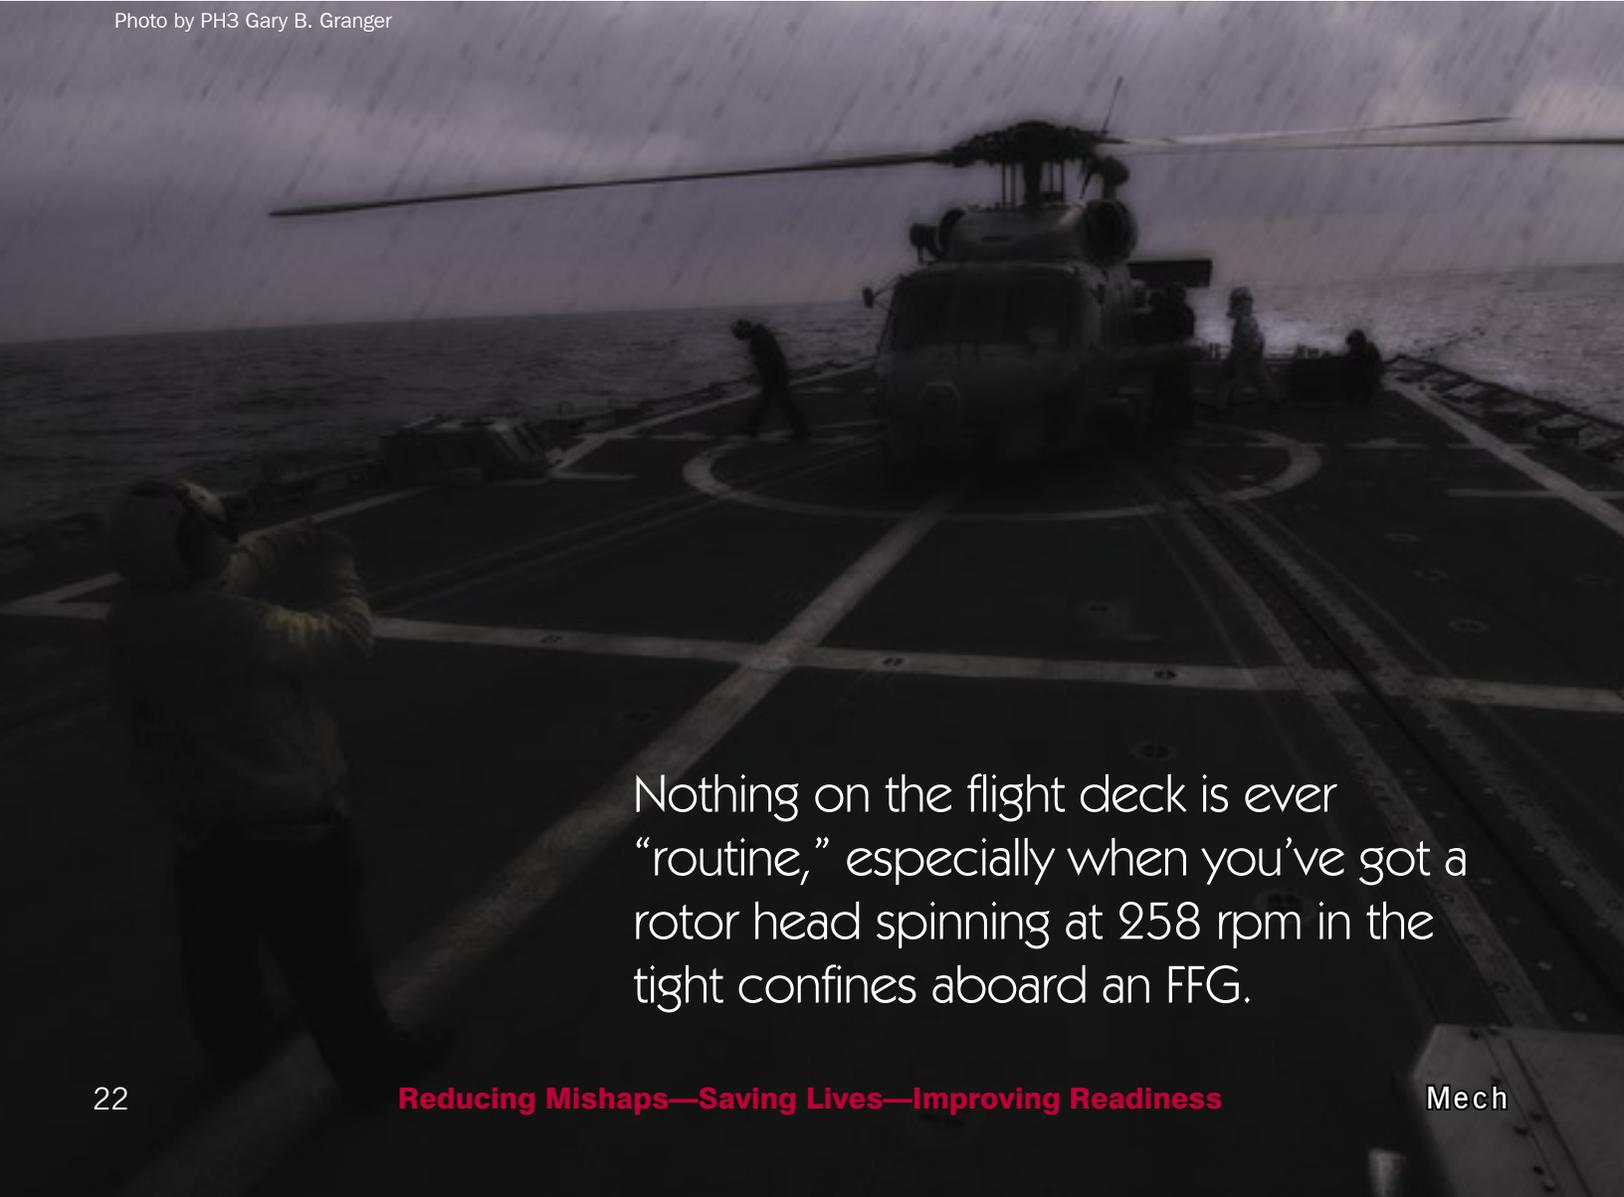
Photo by PH3 Gary B. Granger

Nothing on the flight deck is ever “routine,” especially when you’ve got a rotor head spinning at 258 rpm in the tight confines aboard an FFG.
