# Mech

**Warning: Explosive LCFUs**

**Vol. 45, No. 1 Winter 2005-06**

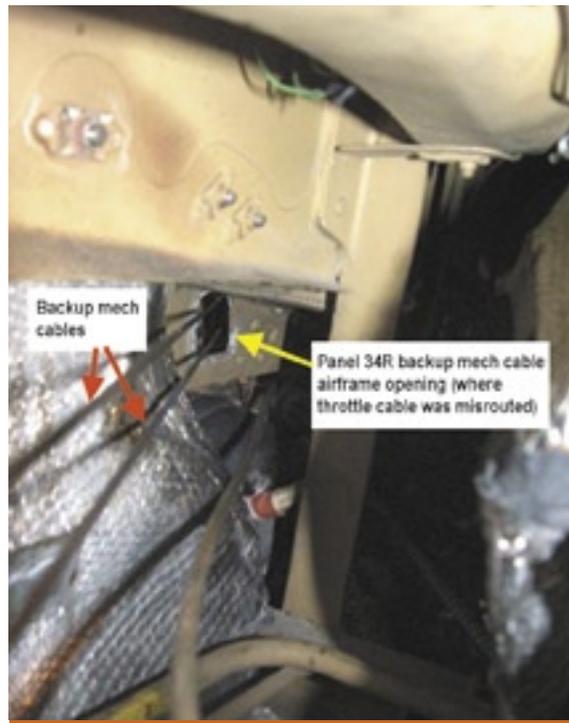
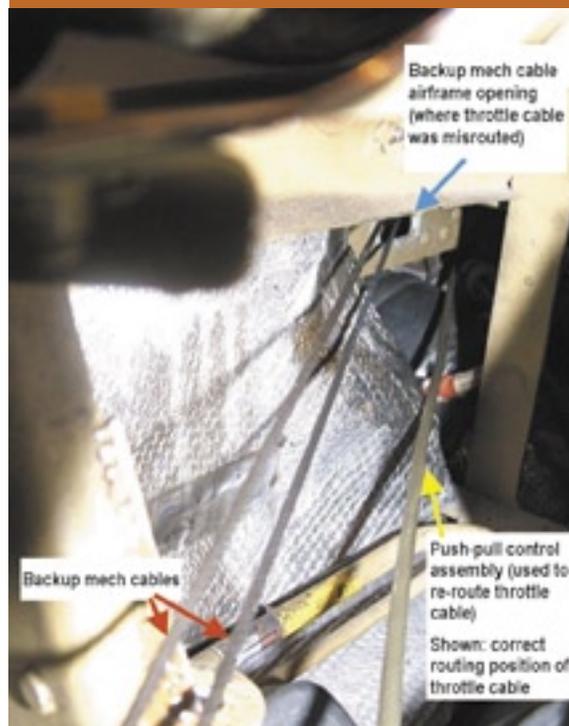
all portions of the back-up mech cables that were visible in any of these open panels (hence the 18-inch rule). While inspecting the cables in panel 34 right, he noticed that the middle throttle cable for the right engine showed signs of rubbing and chafing. Further inspection revealed a groove worn into the shielding around the throttle cable. In one place, the shielding was worn through, and the throttle cable itself was damaged. AD1 Lindsay thought, "This is not good!"

The middle throttle cable was routed through the horizontal-stabilizer, flight-control-cable cutout, along with the back-up mech cables. Petty Officer Lindsay believed the throttle cable was misrouted and this misrouting had caused the damage to the throttle cable. He checked the aircraft publications to verify his suspicions. The pubs did not discuss or show the specific routing for the middle throttle cable in panel 34 right. He conferred with his fellow ADs, and they agreed the cable was not routed properly. However, none of them could prove it with the current aircraft publications.

Fortunately, the Boeing representative was able to provide the technical drawings that proved the cable was routed incorrectly. The cable was repaired and re-routed correctly—underneath the horizontal stab cutout, vice through it.

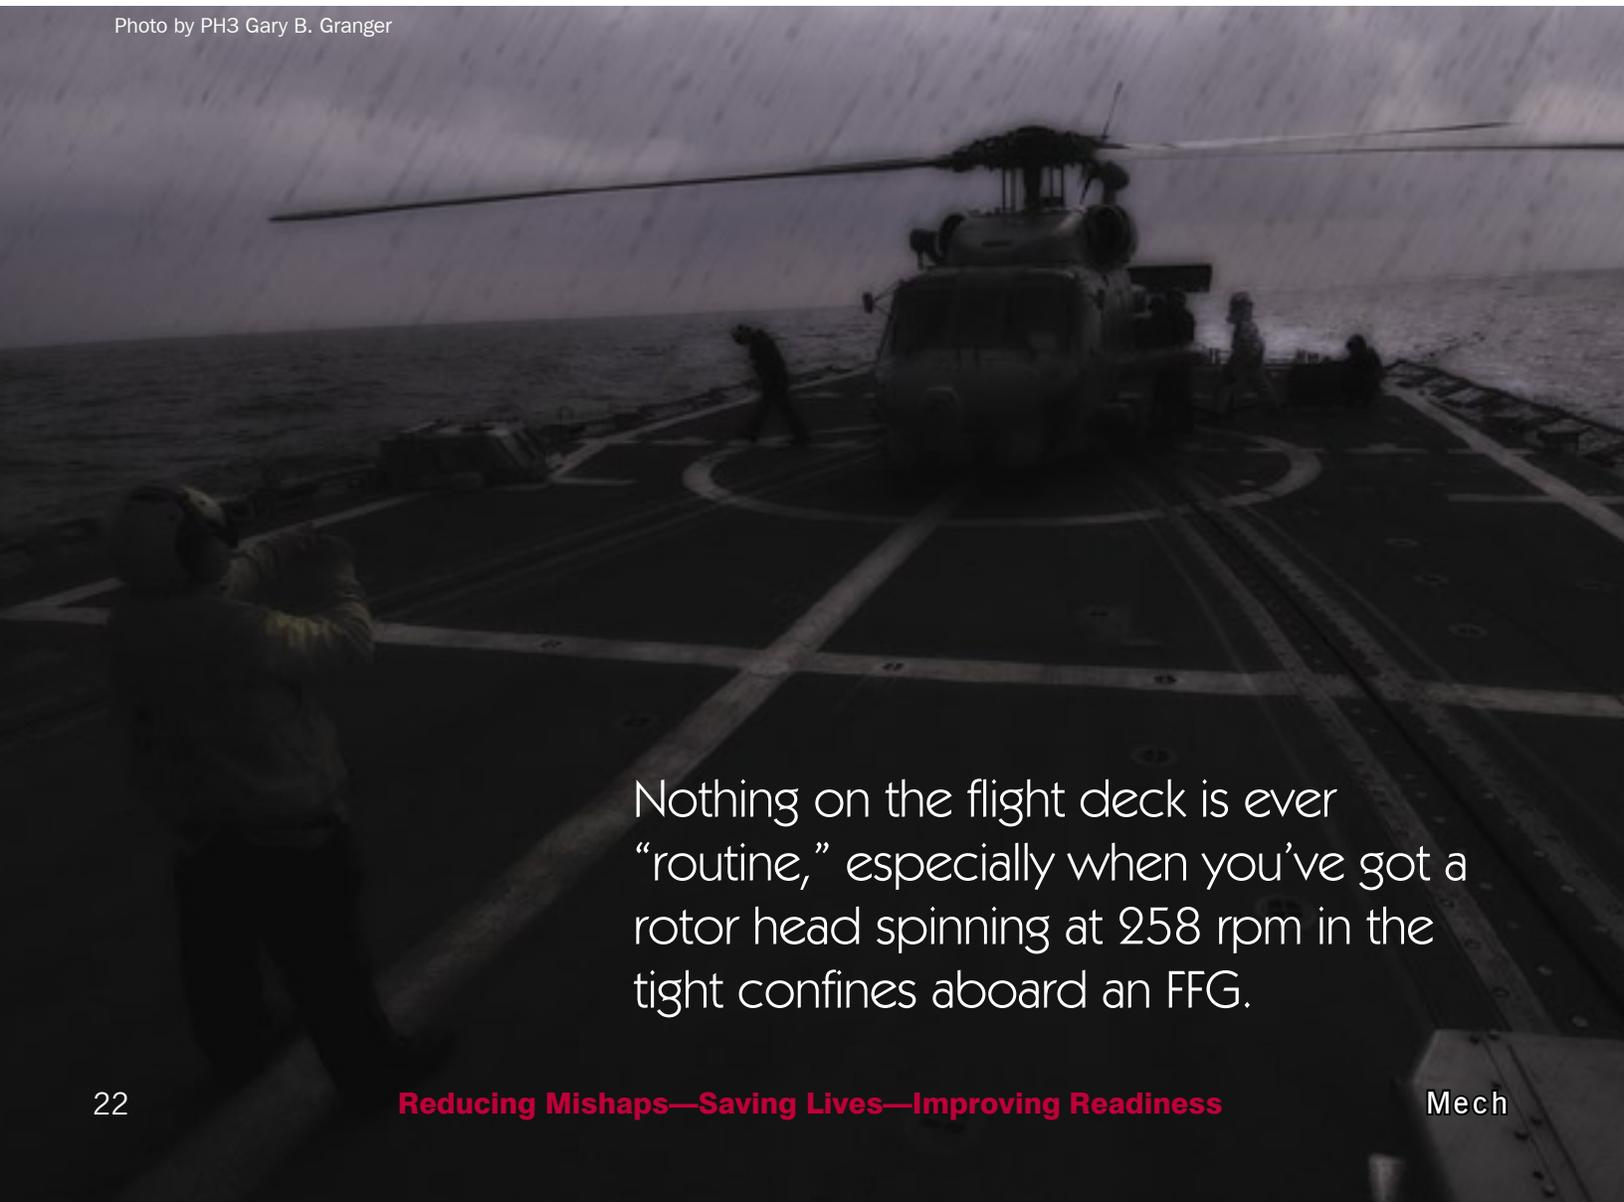
Photo by PH3 Gary B. Granger

Nothing on the flight deck is ever “routine,” especially when you’ve got a rotor head spinning at 258 rpm in the tight confines aboard an FFG.

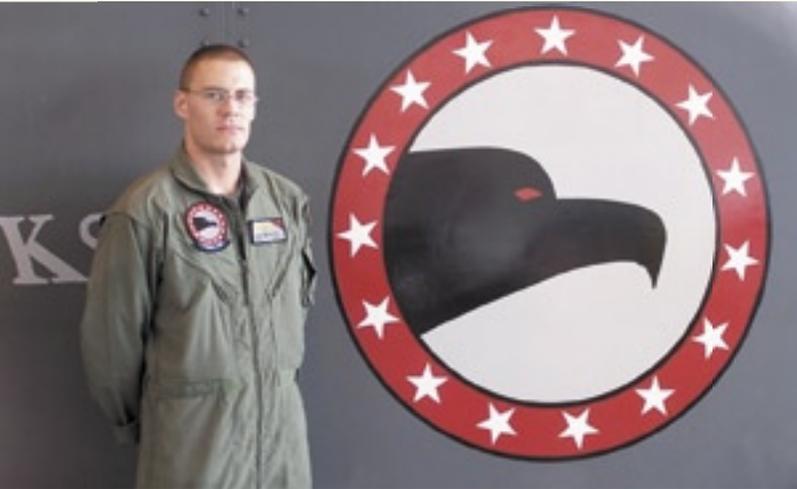
**AM3 Michael Monroe**  
HM-15

Petty Officer Monroe noticed a broken section of the cowl screen on the tail gearbox while preflighting the tail-rotor driveshaft on Hurricane 07. Although the daily and turnaround inspection had revealed no discrepancies in that area, he notified his crew chief. Upon closer inspection, the crew chief found the screen had separated and peeled back from the airframe.

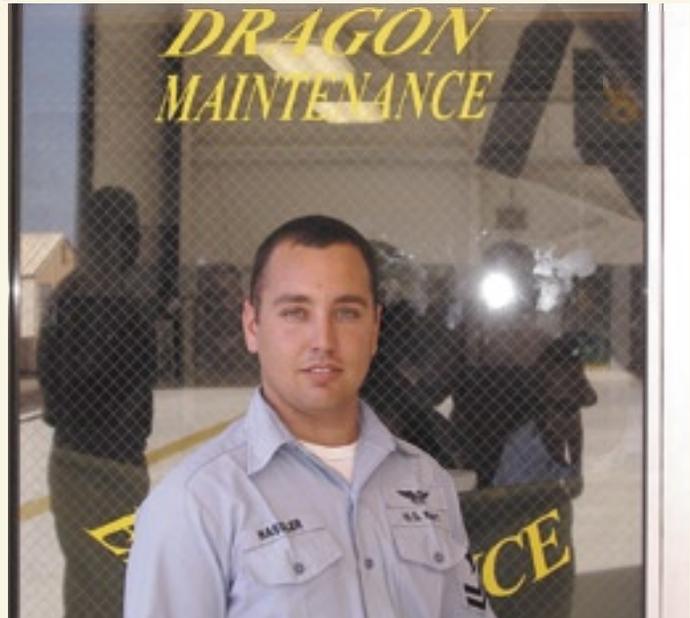
**AM2(AW) Kenneth Hassler**  
HS-11

During a daily and turnaround inspection, Petty Officer Hassler discovered a half-inch-by-7-inch delaminated section on the blue tail-rotor blade. He immediately downed the aircraft until critical repairs could be completed.

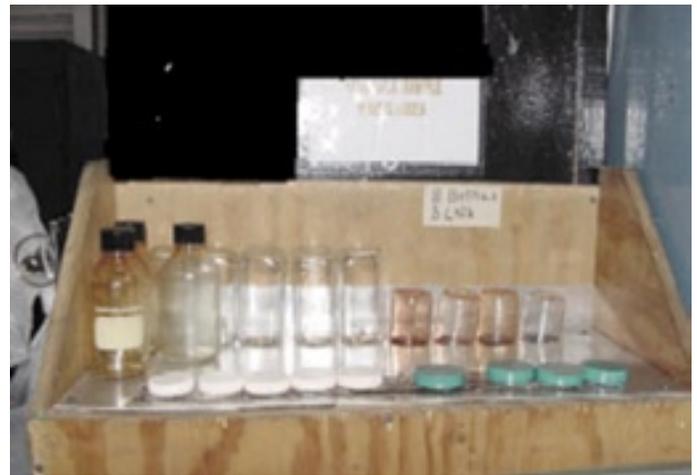
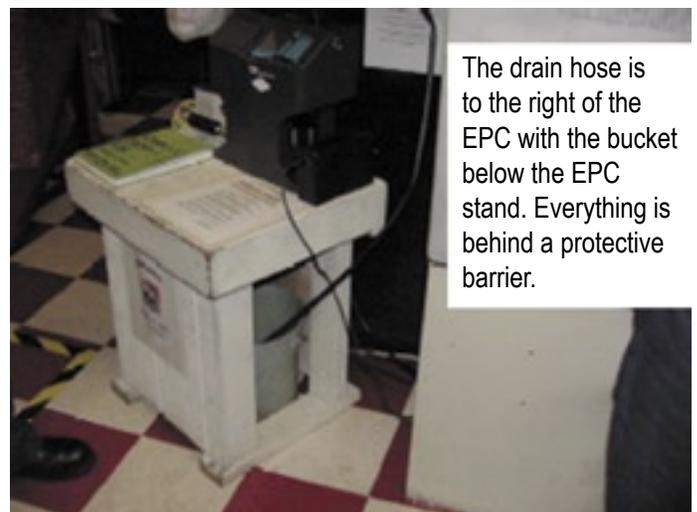
Airframers at VFA-211 designed a platform that allows bottles to drain with a canted catch pan under the table. The fluid then collects at a drain in the lowest point of the catch pan. At the drain, a hose is attached that allows the fluid to drain into a bucket. The drain table is not used solely for patch-test-kit bottles. They also use it for their electronic-particle-counter sample bottles.

The drain hose is to the right of the EPC with the bucket below the EPC stand. Everything is behind a protective barrier.
