A Sailor's Last Liberty Call

By Ken Testorff,
Naval Safety Center

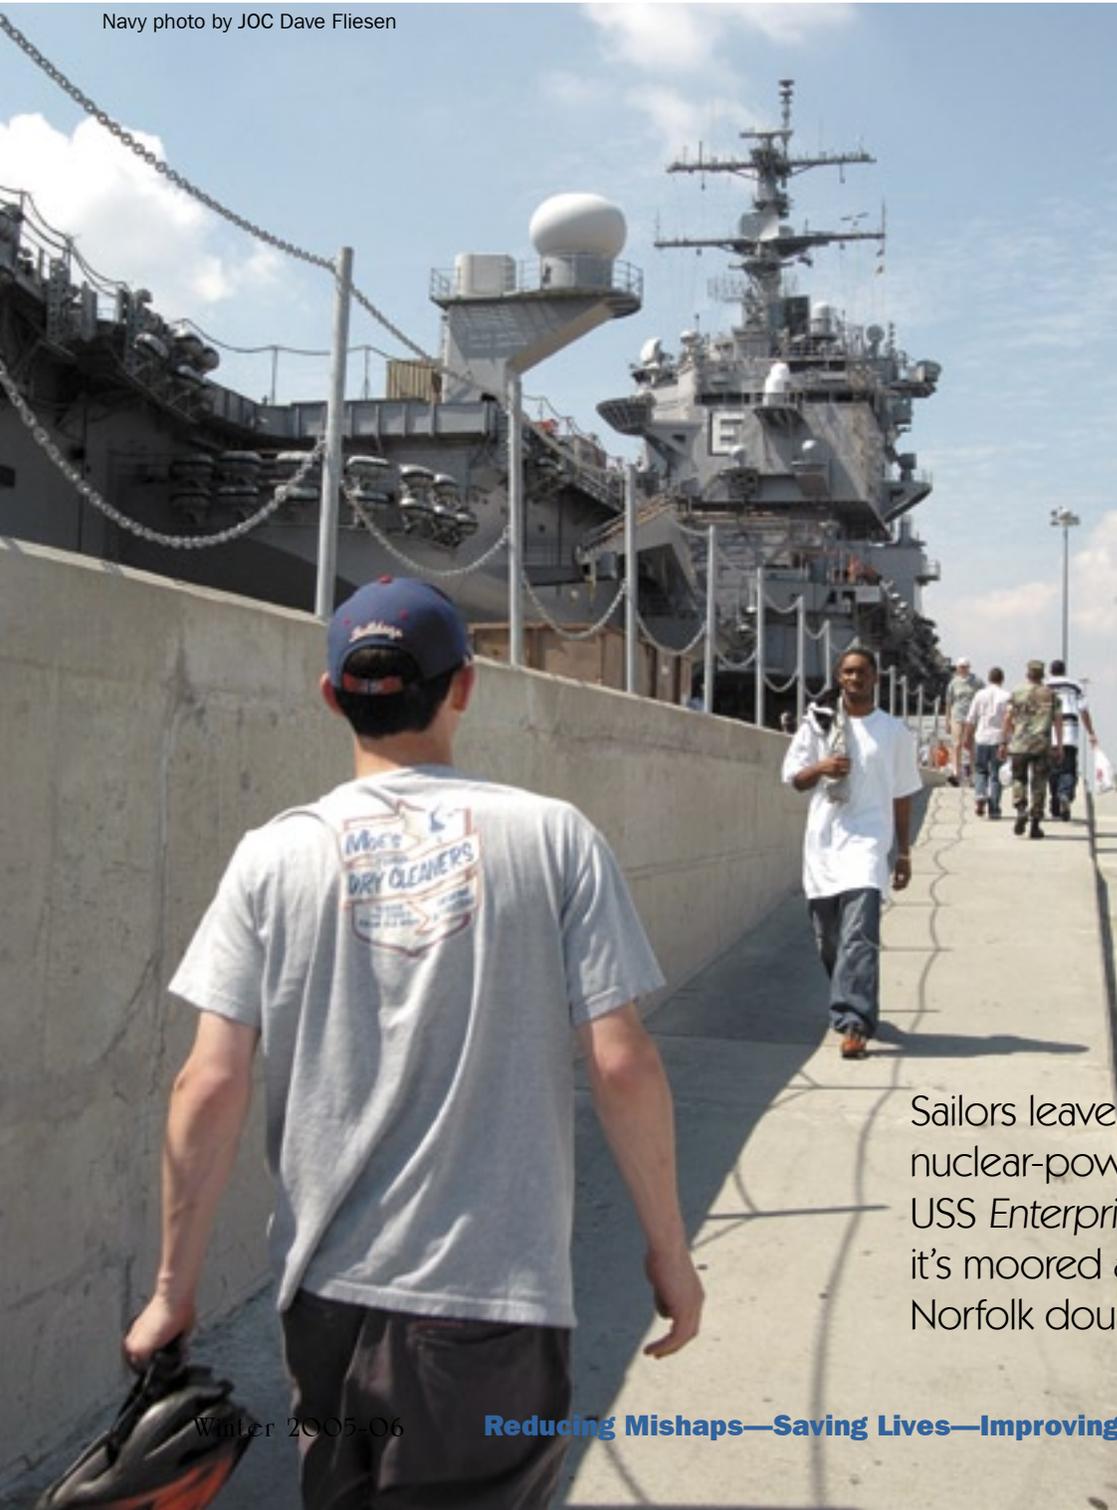
Sailors leave and return to the nuclear-powered aircraft carrier *USS Enterprise* (CVN-65) while it's moored at a Naval Station Norfolk double-deck pier.
