Handling the GSU-323/E Buddy-Store Dolly

By ASC(AW/SW) Joseph Funderburk

What Did You Say?

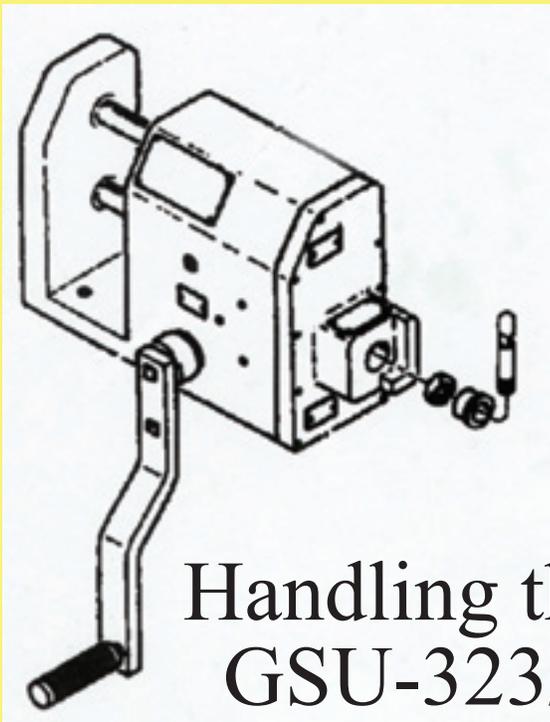
Petty Officer Riebel wrote about poor design, improper pre-op checks, and insufficient training. The initial design of the winch handle used a spring-and-ball lock mechanism to secure the handle in place. The winch handle was not sturdy enough to withstand the constant demands of flight operations, would fail and injure people, or would become a FOD hazard. Support Equipment Change 5462 was issued Jan. 31, 1999, to fix early problems. This document instructed

all commands to modify existing dollies with Velcro straps that secure the handle in place. These straps are not shown or addressed in technical manual AG-ARSHD-OMP-000 or in the illustrated parts breakdown, meaning commands must use the SEC to manufacture new straps. Interim rapid action change No. 1 was issued Sept. 12, 2002, for 28-day cards in the MRC deck AG-ARSHD-MRC-000 (part number 3223AS500-1). It was issued to inspect the Velcro straps for frayed condition, cuts, and overall integrity. A visit to a pierside carrier revealed four of six dollies needed new Velcro straps and winch assemblies. The photo in Petty Officer Riebel's story shows a worn inner hub.

The item manager is Mr. Steimkey, and he said the new dolly—part number 3637-AS600—has a redesigned assembly, with a quick-release lock pin. He also explained this new dolly slowly will be phased into the fleet, and the original dolly will continue in service for a long time. We strongly recommend any command that owns or repairs the ARS handling dolly to do a one-time inspection of the straps and winch assemblies.

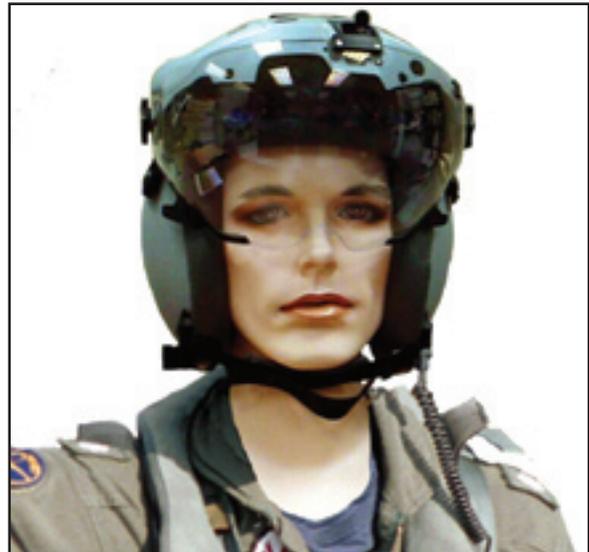
When you hear cathode-ray tube, magnetic-receiver unit, relay-optics assembly, up-look reticule, upper helmet-vehicle interface, and a camera, it sounds like the ATs really are going to be busy. But in the not-too-distant future, PRs will be elbow-deep in the new, joint helmet-mounted, cueing-system helmet. It features the technology listed above.

This revolutionary helmet has a display system that projects cueing symbology for navigation, weapons and targeting onto the visor assembly. All of this equipment comes packaged in a helmet that weighs just 4.1 pounds.
