Preventing Corrosio

What you don't see can hurt you!

By AM1(AW) Vener Maranan

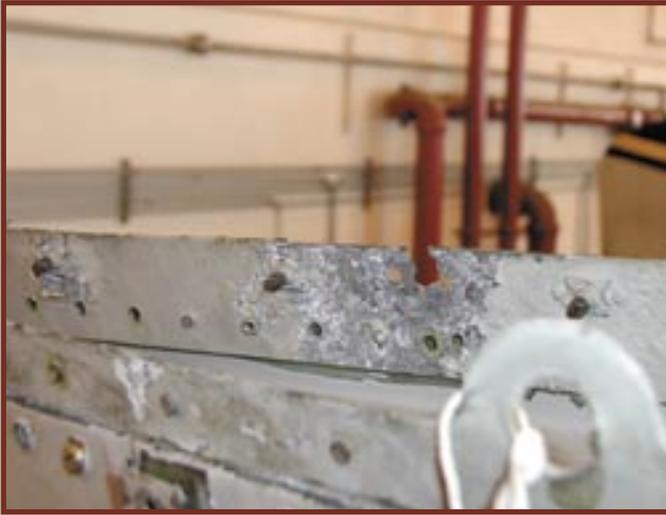
During the QA walkaround inspection, we found numerous corroded fasteners (screws and rivets) on the vertical-stab assembly, specifically on the port, upper and inboard side. Quality assurance wrote a VIDS/MAF for airframes to remove and replace the

fasteners. Because they were covered with heavy paint and sealants, we had difficulty identifying the extent of the corrosion, until the airframers began to remove some of the screws. That's when AM3 Cervantes and AM3 Manuel Garcia discovered the problem was migrating along the metal surfaces.

It wasn't an easy task to remove all the screws and rivets because most of them were stripped and corroded. Petty Officer Garcia decided to remove all the fasteners from the upper cap assembly, which is attached to the vertical stab. This step would allow him to find out how far the corrosion had migrated.

The photos in this story show the damage, and most of the maintainers reading this story quickly can identify the corrosion types. What appeared as a small area of surface corrosion actually turned out to be the most severe and deadliest form of corrosion: exfoliation! That category means it is so bad that most of the metal is destroyed. The doublers that support or attach the cap to the vertical-stab assembly were affected badly. We removed the doublers and sent them to AIMD to be remanufactured.

How could a problem this bad go undetected for so long? Was it because of poor maintenance practices or procedures that do not exist in the MRC decks? For one thing, no conditional inspection exists to remove this cap assembly to see what is hiding behind or

underneath it. The corrosion manual (NAVAIR 01-1A-509) does not list this area as corrosion prone. During 800-hour inspections, we remove all movable rudders and tabs to inspect the bushings and bearings. They then are replaced. However, the Hawkeye's port, upper, inboard, vertical fin is not a movable rudder. It has no bushings or bearings to replace, and it is not subject to this inspection. We often treat this area with the saying, "If it isn't broke, don't fix it."

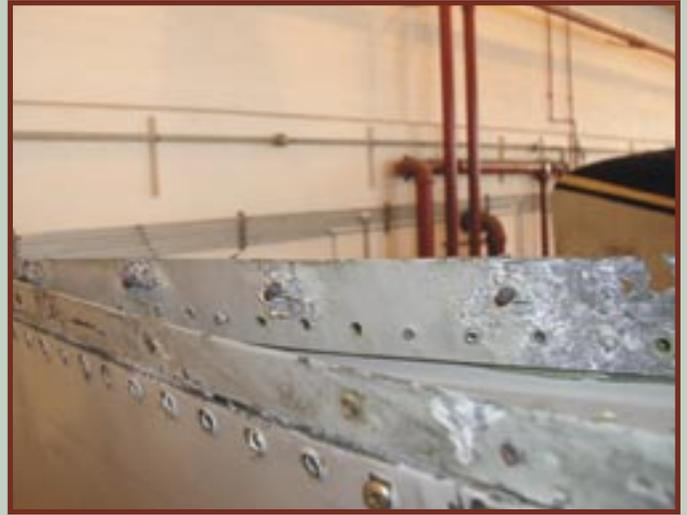
The corrosion types are evident, including exfoliation.

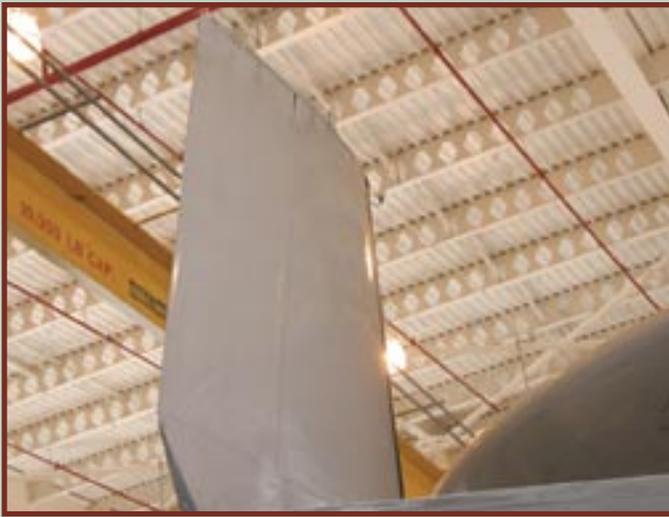
The upper cap assembly is not a corrosion-prone area.

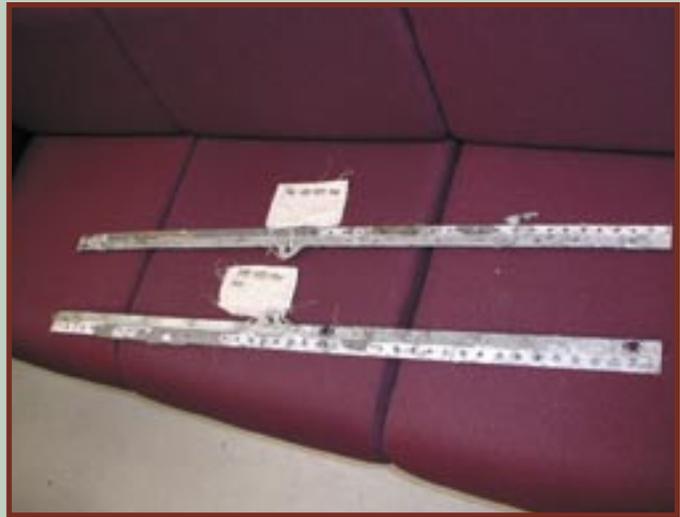
The doublers show the extent of damage.

Using good maintenance practices and taking pride in an aircraft are two ways to help combat these types of corrosion. Everyone has the responsibility to detect and report any type of this insidious problem to maintenance control. Corrosion will appear where and when you least expect it. Fortunately, the only real damage was to the doublers. The other areas were made out of fiberglass.
