Helicopter Engines and Desert Environments— **Who Wins?**

*By Thomas Harless and William Stelk,
Naval Air Depot, MCAS Cherry Pt., N.C.*

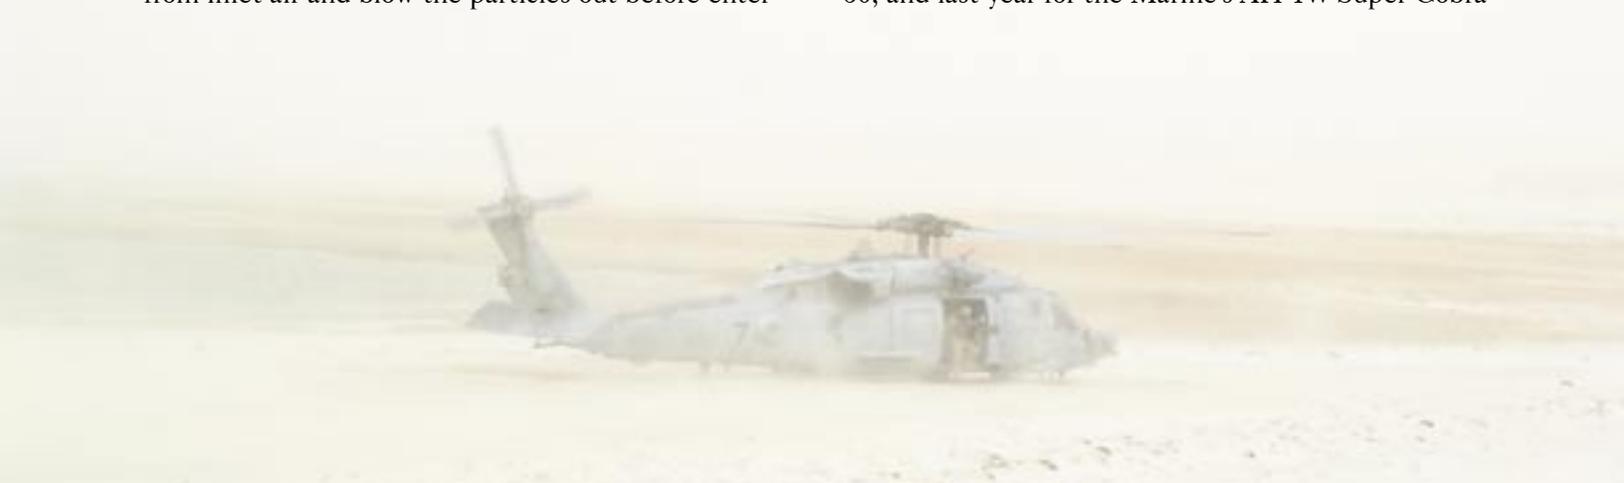
The T700 engine is unique in that it has a built-in integrated particle separator (IPS) blower as part of the engine's accessory gearbox.

Low power is the major cause for engine removal in the Navy's H-60 fleet. For SH-60B, SH-60F and HH-60H aircraft, powered by two T700-GE-401C turbo-shaft engines, if you spend time on preventive maintenance (such as engine washing), aircraft readiness and engine performance will improve. The T700 engine is unique in that it has a built-in integrated particle separator (IPS) blower as part of the engine's accessory gearbox. It was designed to separate sand and dirt from inlet air and blow the particles out before enter-

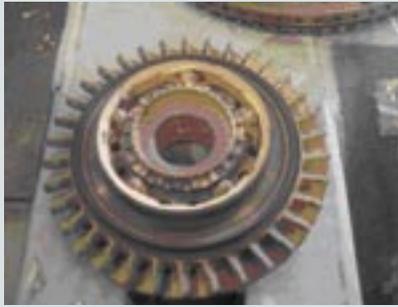
T700 Engine Stage 1 Gas Generator Rotor

No washing performed

ing the compressor inlet. However, operating in desert environments has posed a major problem: Too much debris makes it past the IPS and enters the compressor. These tiny particles erode compressor blades and coat hot section (gas generator turbine) parts, which plugs cooling air holes, therefore decreasing hot-section efficiency.

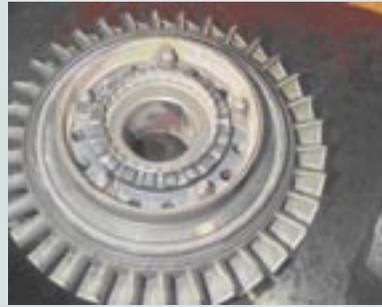
Washing performed

NAVAIR and the T700 engine team have been working to improve engine life in this environment. We have found that preventive-maintenance washing procedures are critically important. Based on lessons learned during Desert Storm and Desert Shield, a hot-section wash-sprayer nozzle was developed to perform hot-section cleaning in the T700 engine. Hot-section cleaning is done by installing a wash nozzle into one of the engine's igniter plug ports and spraying soap solution (engine gas path cleaner) on the hot-section parts, while the engine is motored. During 2003 for the H-60, and last year for the Marine's AH-1W Super Cobra
