H-46 WIRING SYSTEM AWARENESS

PREVENTING WIRING SYSTEM FAILURE SAVES TIME, MONEY...

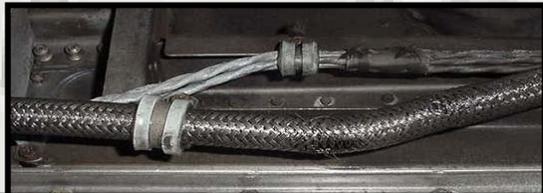
Braided line chafing on structure.

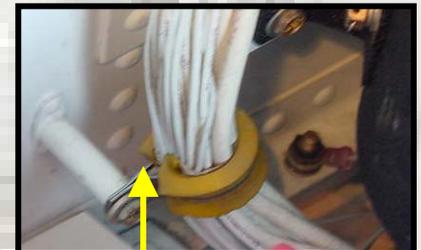
Wires outside of clamp rubber wedge.

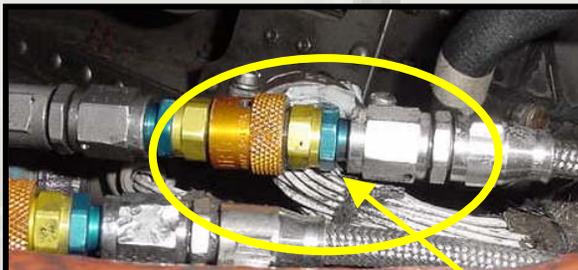
Harness chafing on hydraulic line.

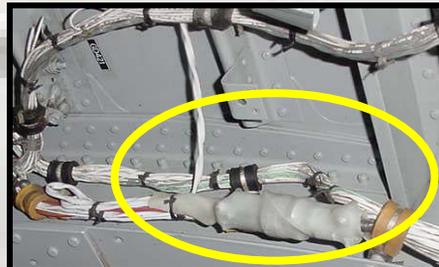
Connector disconnect not properly stowed.

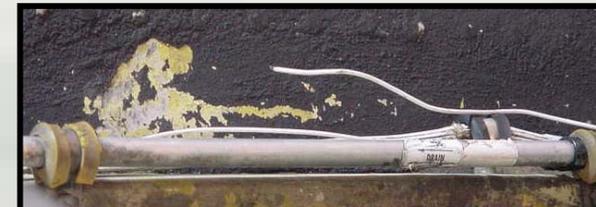
Broken/Uncapped wiring.
