# HANGING ON BY SOME BOLTS

By LCdr. Steve Blasch

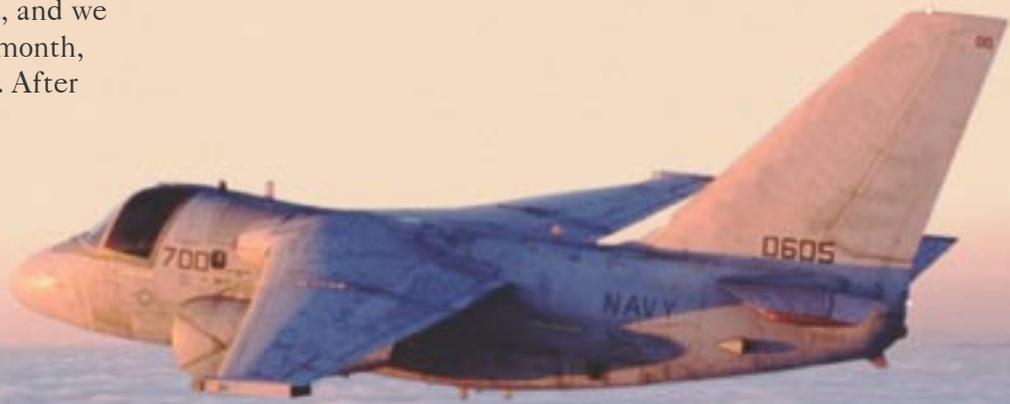
Now that we were safe on deck, we could unravel the mystery of what went wrong with the aircraft. We exited and joined the crowd around the No. 1 engine. To our surprise, the entire aft section of the engine tailcone had broken off and was hanging in the breeze. It

was held on by just three of the more than 30 bolts that secured it to the aft end of the engine.
