Fingers: Flexible, Handy... and Fragile—Case No. 2

By AM2 Dale Hazelton

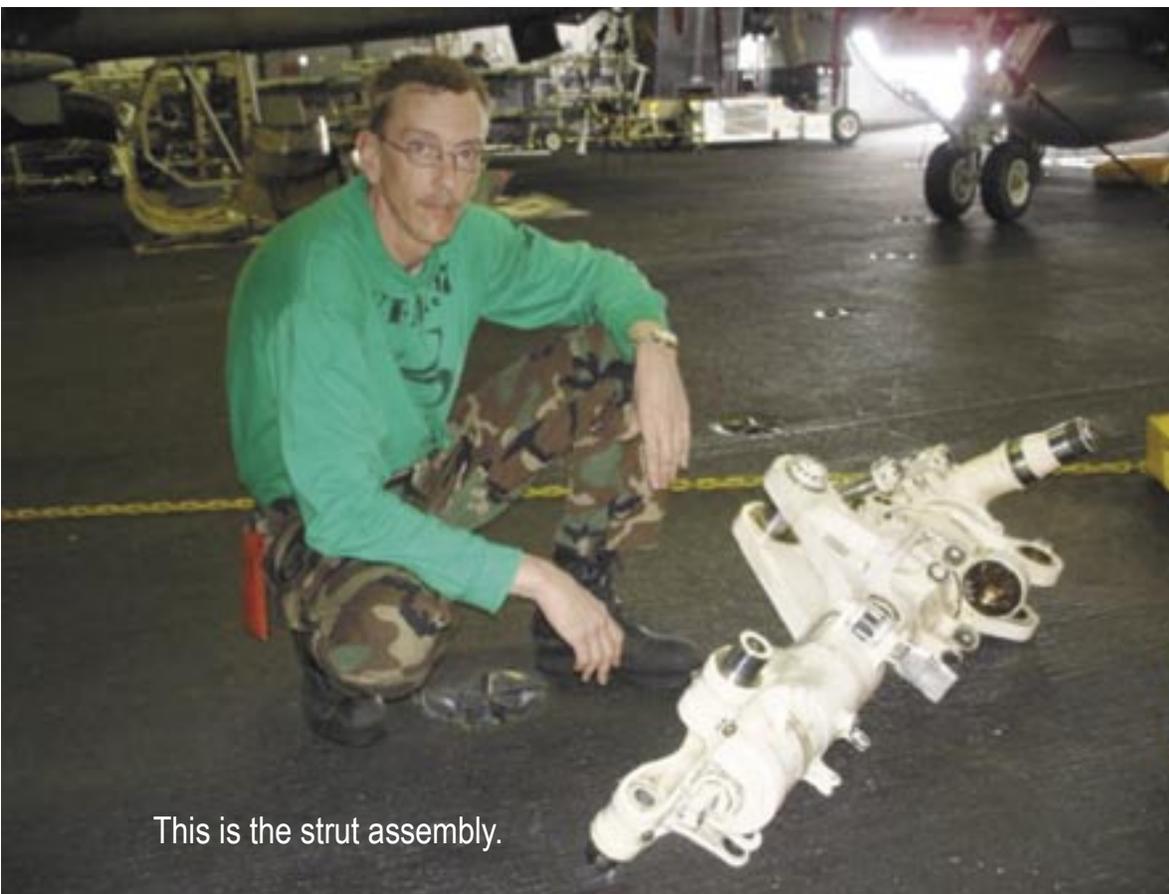
For those of you unfamiliar with the strut assembly, three holes are on top of the housing assembly. Two of the small holes on each side are for servicing the strut. The larger hole—top dead center—allows the metering pin to slide through. With one more bounce needed to seat the housing, I wanted to get a good grip on the strut. Grabbing the assembly around the top with one hand, I placed the other hand right on top, with the ring finger inside the large center hole. We then gave the strut one last bounce.

With this final bounce, the housing seated onto the piston while the metering pin tried to come through the hole—yes, the same hole where I had placed my finger. I got an instant broken finger: black, blue and purple. I hadn't realized I had put my finger in the

This is the strut assembly.

What had gone wrong this time? Where or when was ORM applied in our procedures? This incident showed that just because “we always do it this way” and are in a hurry doesn't mean it always is done the right way. Had we taken time to assess the situation and identify the hazards, I would have kept my finger out of that hole and out of a cast. 🙄
