# So Much for a Routine

By AMS2 Shawn Gray

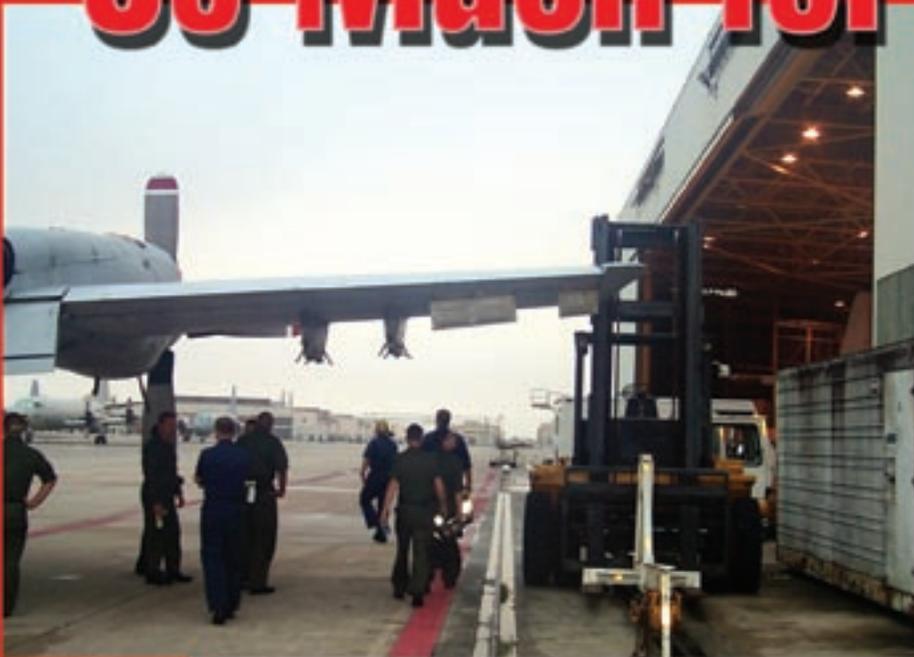
A huddle around an aircraft never is a good sign.

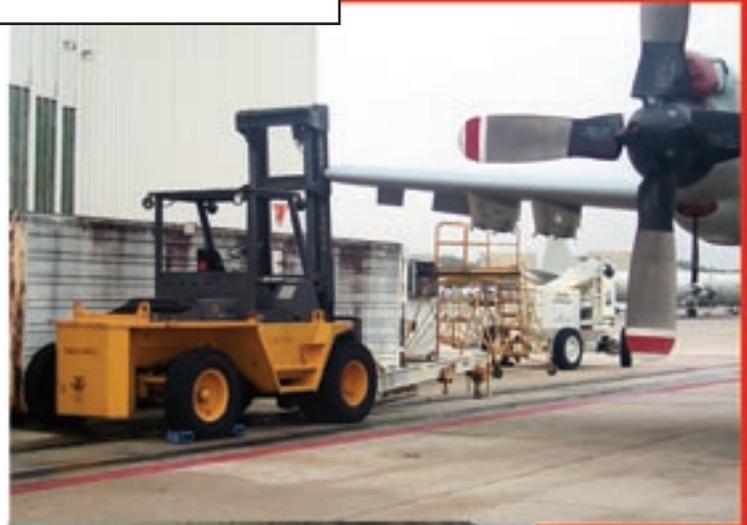
The wing appears to clear the obstacles, but...

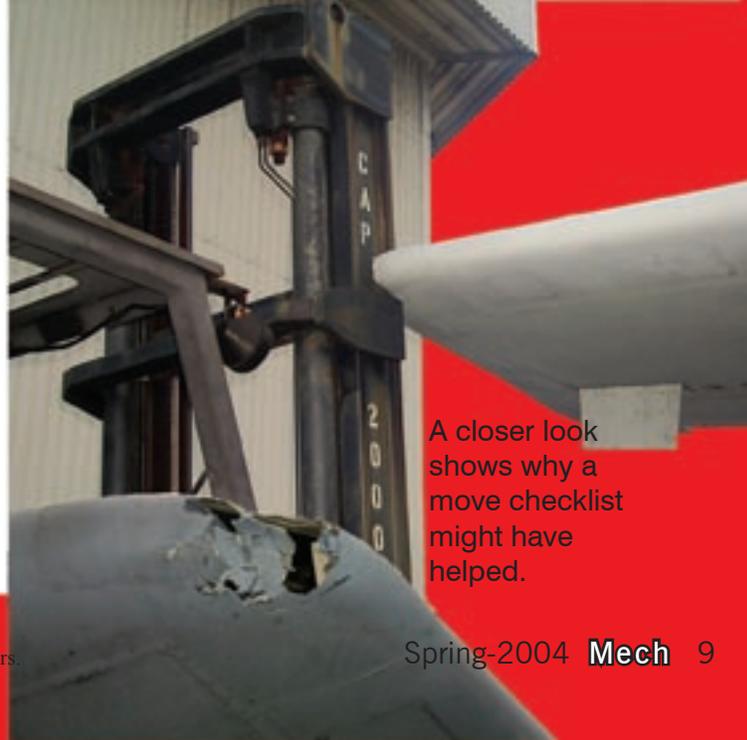
A blast from an air horn pierced the air, signaling the tug operator to stop immediately. When the aircraft came to rest, I walked over to the starboard wing walker and discussed how we would get around the forklift. To my disbelief, the wing already had struck the forklift, piercing the leading edge. The move was halted, and I notified maintenance control and the safety department.

A closer look shows why a move checklist might have helped.

I can imagine what many readers are thinking. I, too, am amazed at how this happened. So what went wrong? We did not do a pre-move brief. We were complacent. We knew each other very well and had done routine moves, like this one, many times in the past. In hindsight, a brief would have given us a much-needed focus after the long weekend. A quick brief also would have allowed me to learn what the safety department found after the mishap. Yes, hindsight is 20/20.
