# CROSSFEED

## AVIONICS

### You're Not Supposed to Be Part of a Circuit!

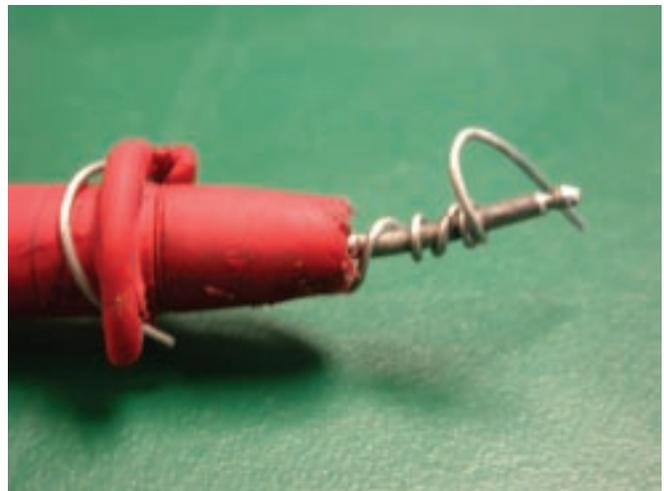
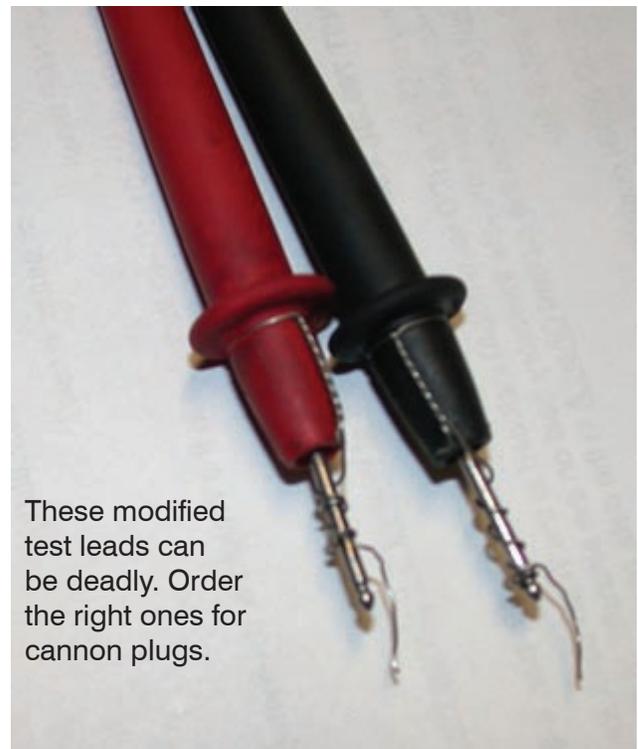
The top photo on this page [and the one in the Good, Bad and Ugly department—Ed.] shows safety wire attached to the leads. It is done in such a way that it presents a clear hazard to personnel, not to mention a potential source of FOD. This item was found in an avionics shop, and another set—just like it—was found in the squadron's tool room.

These test leads are used with the ubiquitous Fluke-77 multimeters. It has a tip that is too large to probe many cannon plugs and test points. A resourceful technician, surely intent on solving his problem and fixing an aircraft, modified it to work. Good on initiative...bad on safety. Notice how the safety wire extends past the finger guard, creating a convenient opportunity for any technician to become part of the circuit. This loose attachment also could fall off, causing a serious FOD problem.

These modified test leads can be deadly. Order the right ones for cannon plugs.

Does a fix for this problem exist? Sure! The supply system stocks a test-lead set with retractable tips. These points are small enough to probe the small contacts on most cannon plugs and can withstand everyday use. They cost less than \$10 a set (NSN 6625-01-172-7860).
